# CASE STUDY

**PROJECT:** SLOPE STABILITY ASSESSMENT

**LOCATION:** RADSTOCK

## Former coal yard: Slope stability assessment and geotechnical modelling.

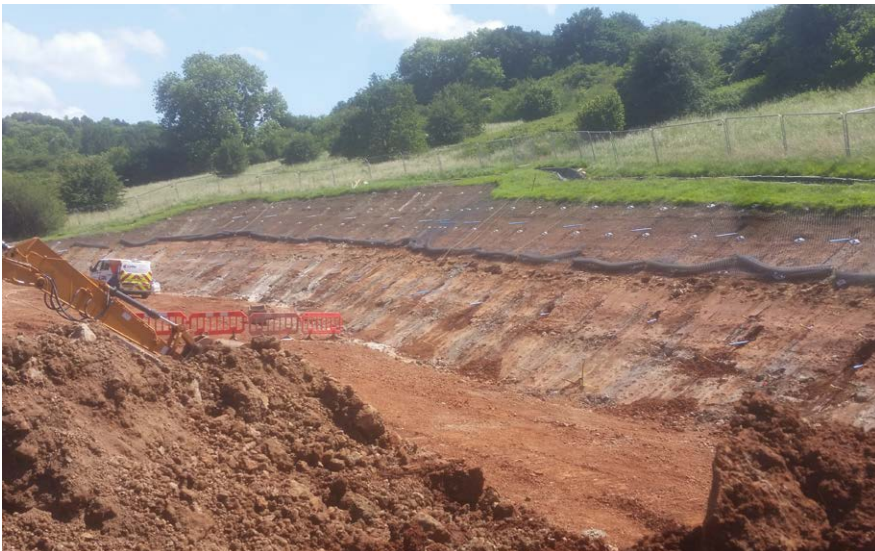
Following completion of the modelling regulators and stakeholders agreed the solution and a soil nailing contractor was selected. An extensive soil nailing operation was carried out as shown in the image above.

Following completion of the ground model in its existing form it was then adjusted for differing proposed final slope configurations. Soil nails were added to these models to increase the safety factor to an acceptable level for the development.
